Impairments to Fluvial Processes and Development of Restoration Strategies on a Dam-Influenced Reach of the Madison River, Montana

RDG
RIVER DESIGN GROUP

Montana AWRA 2024

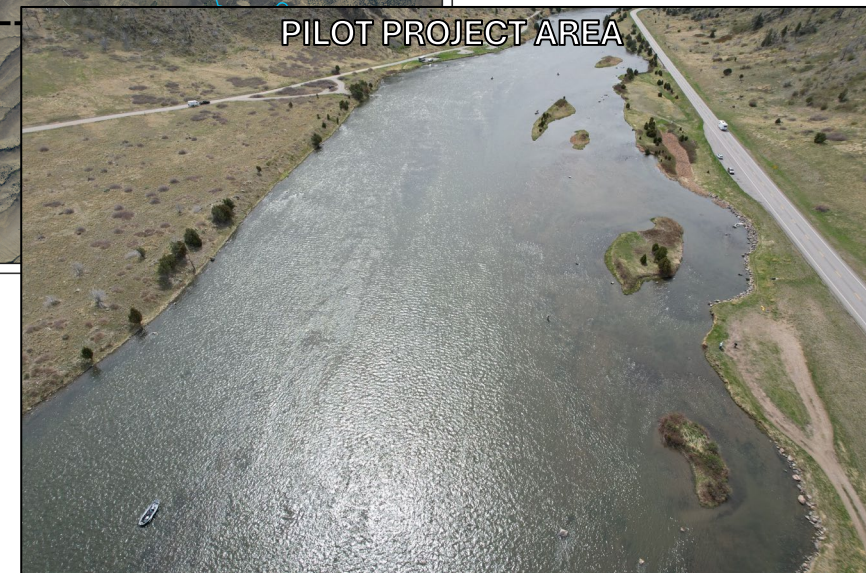
Madison River Sediment Mobility Assessment (Pioneer et al., 2022)

- Norris Reach is becoming progressively depleted of islands
- Ongoing erosion occurring on both island margins and streambanks
- Primary cause for net export of sediment is likely limited sediment supply below Madison Dam
- Redds are concentrated in shallow, low energy areas and on channel and island margins
- Deep, high velocity channel areas exhibit armoring and are deficient in spawning gravels
- D_{50} not mobilized until ~5-year recurrence interval flow

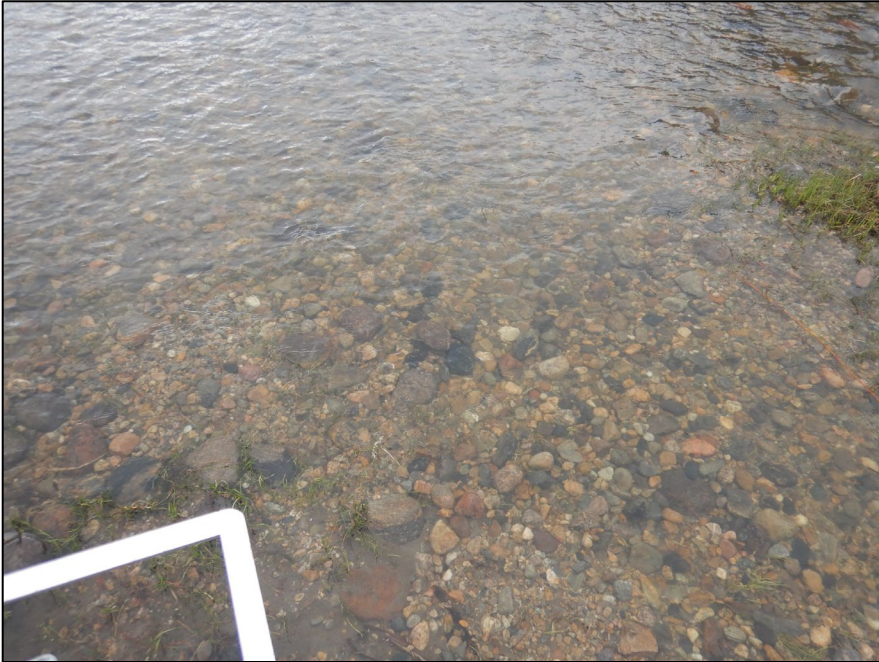
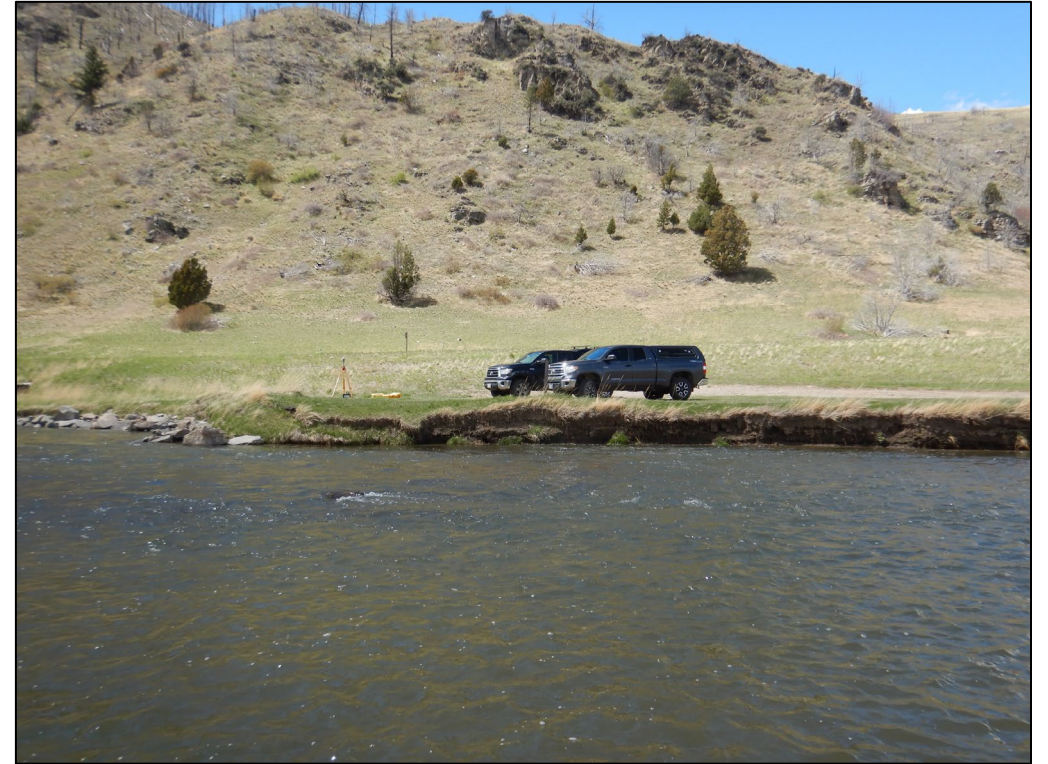
Impaired Fluvial Processes

Hydraulic Complexity

- Habitat diversity for all life stages of aquatic biota
- Sediment erosion, deposition, and sorting
- Hyporheic exchange
- Water quality (O_2 , nutrient cycling)
- Resilience to disturbance (floods, drought)
- Refugia during high flows and high temperatures

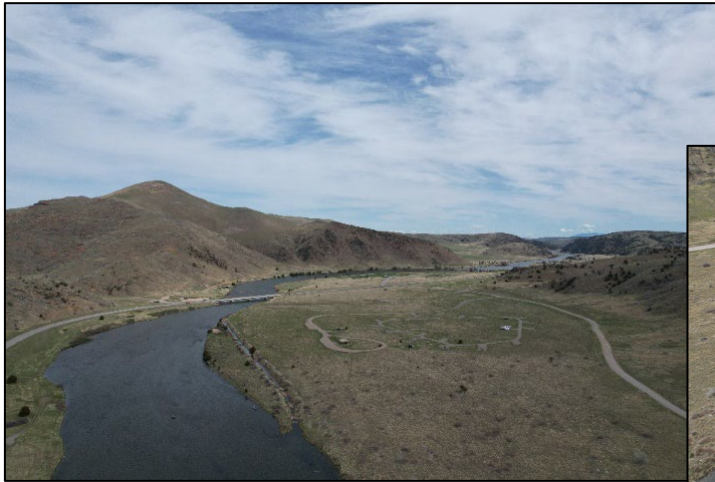
2100 cfs (Q_{field})

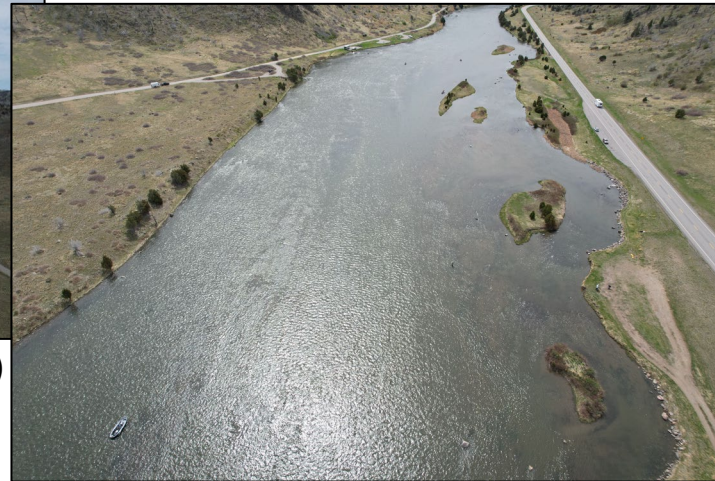
4706 cfs ($Q_{1.5}$)

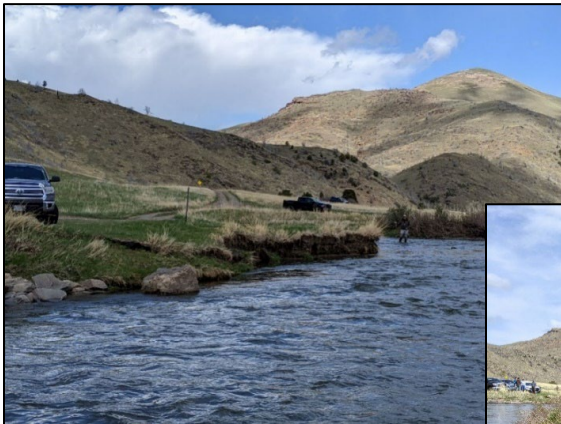
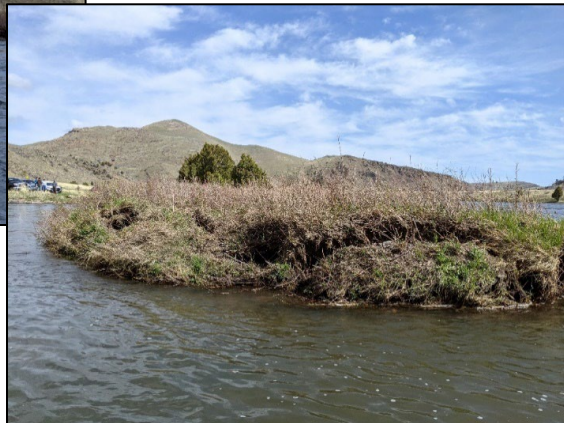
Impaired Fluvial Processes

Streambank and Island Erosion

- Low sediment supply; channel degradation
- Lack of woody riparian vegetation
- Few means of energy dissipation

- Excess fine sediment
- Loss of geomorphic and hydraulic complexity

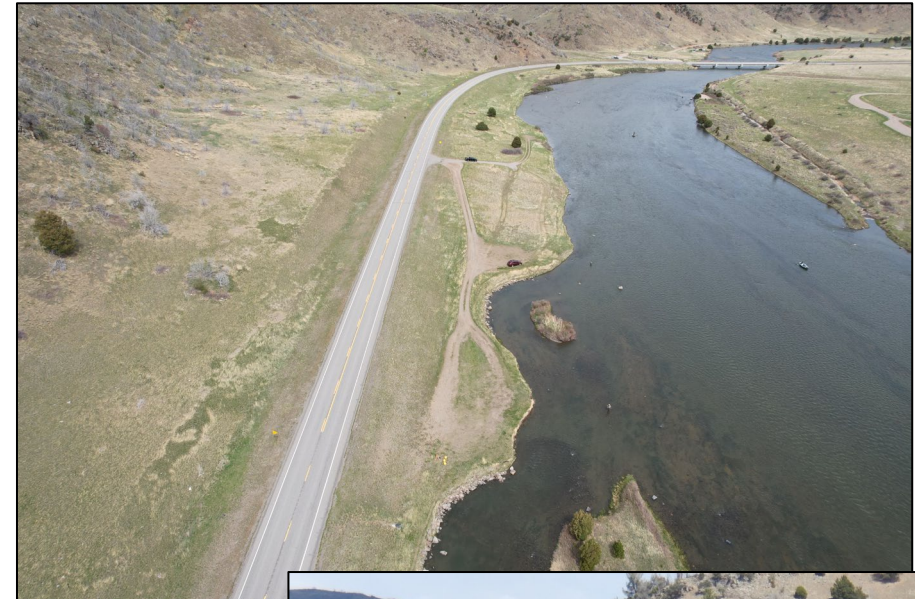
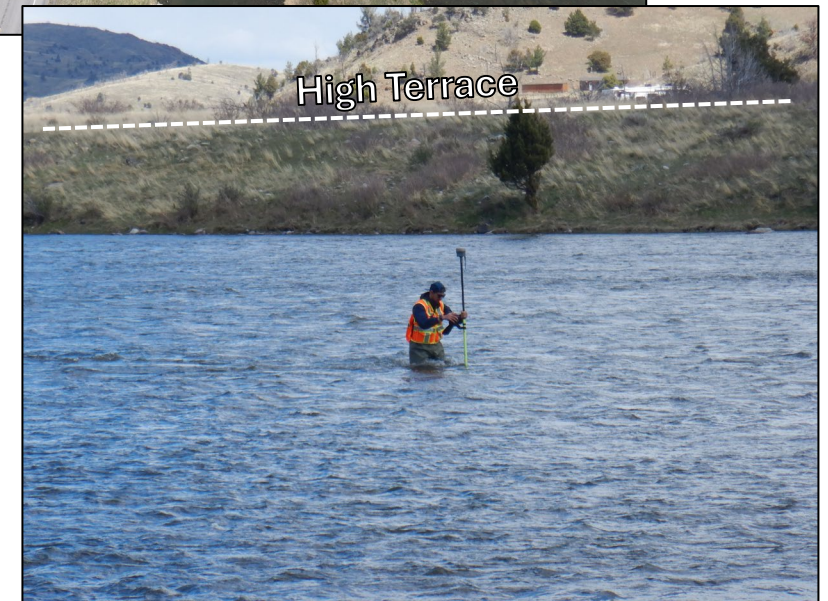
Impaired Fluvial Processes

Floodplain Connectivity

- Water storage
- Sediment storage
- Nutrient cycling
- Off-channel habitat for aquatic and terrestrial wildlife

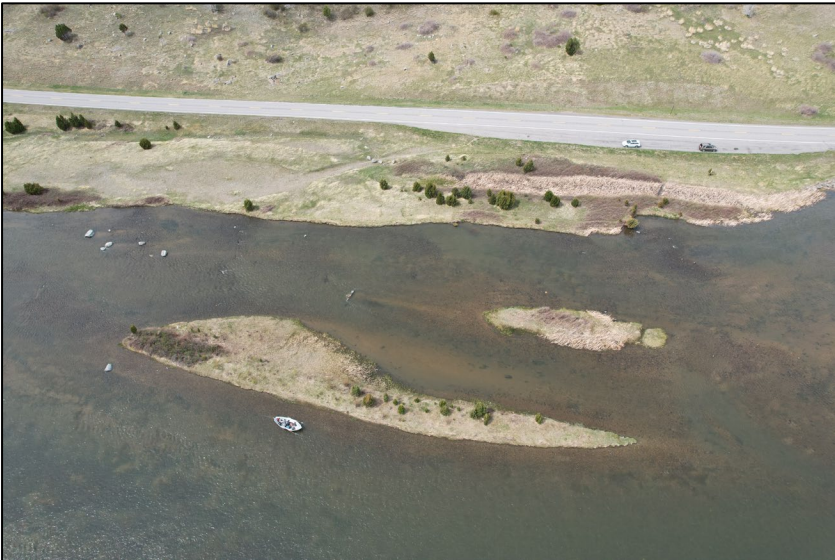
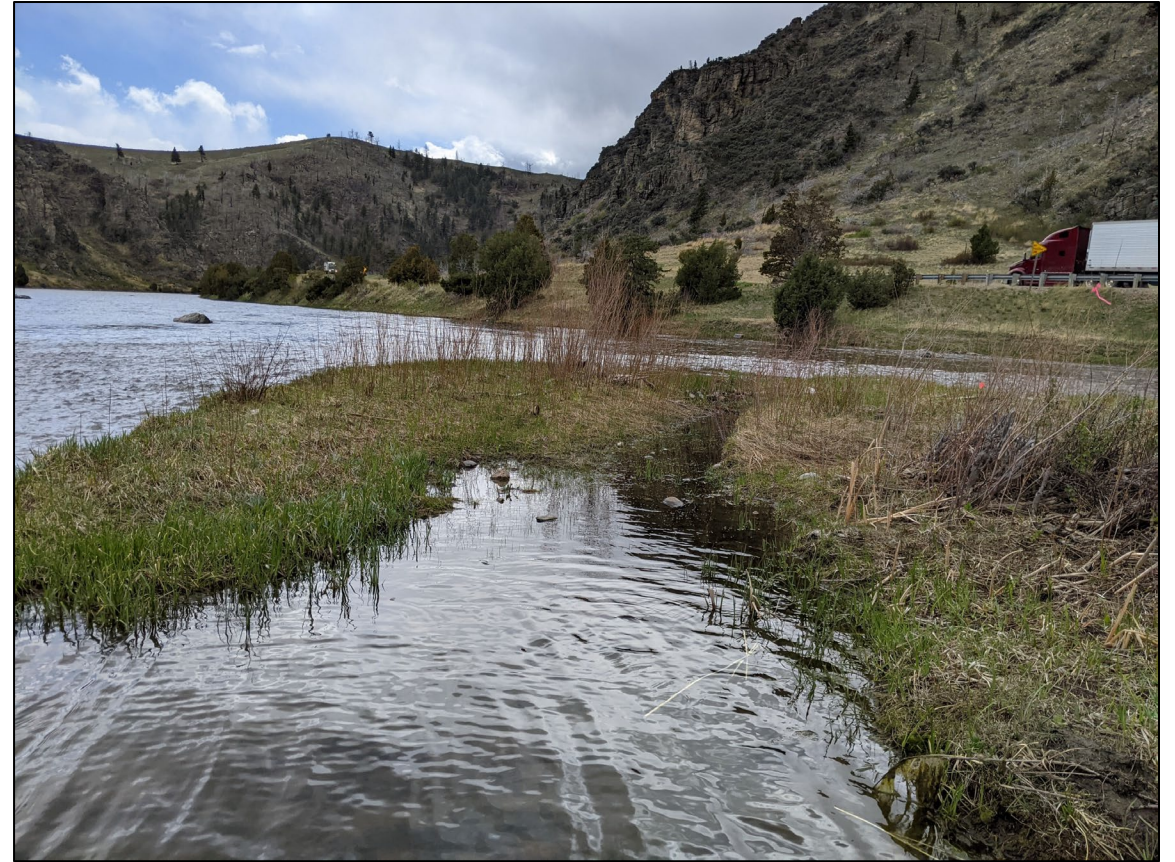
Impaired Fluvial Processes

Woody Riparian Vegetation Succession

- Quality riparian habitat
- Large woody debris recruitment
- Modulating bank erosion
- Aquatic habitat cover and shade

- Floodplain disconnection
- Vegetation conversion

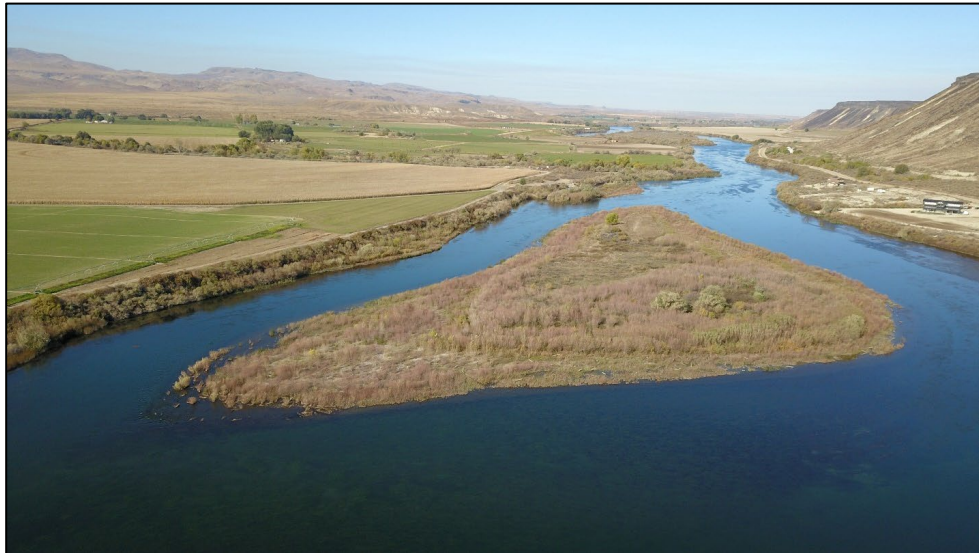
Bayha Island expansion four years post construction, Snake River, ID.

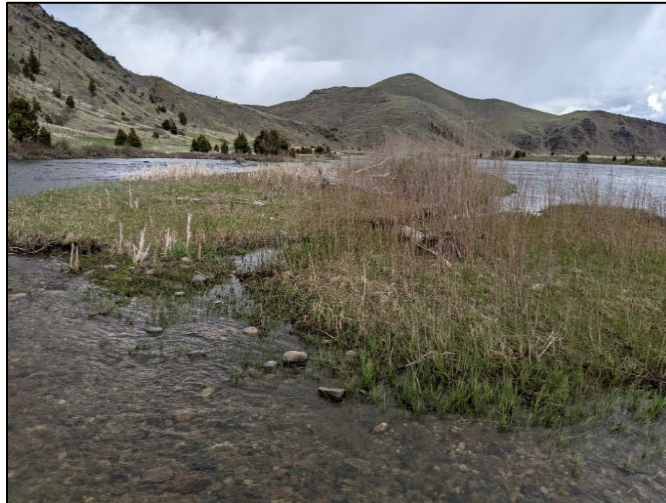
Reference island

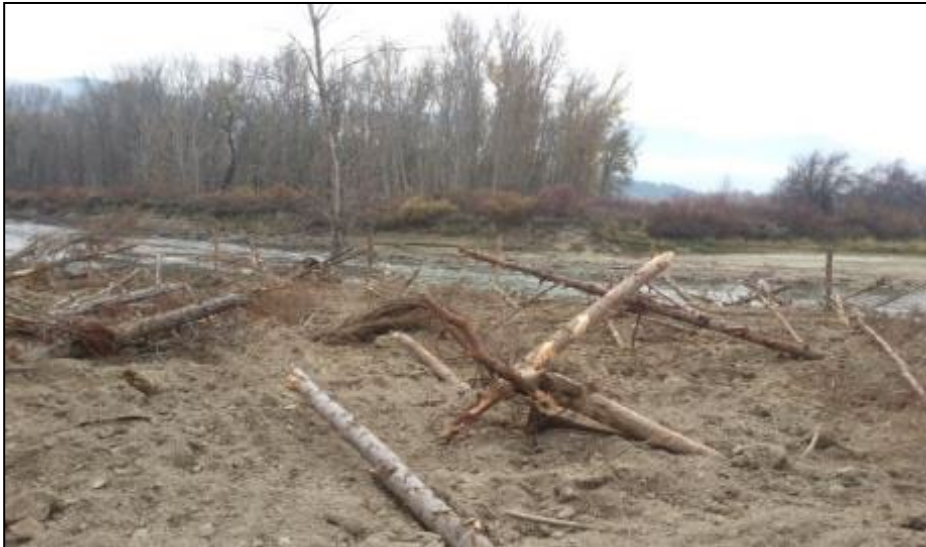
Example floodplain roughness post-construction.

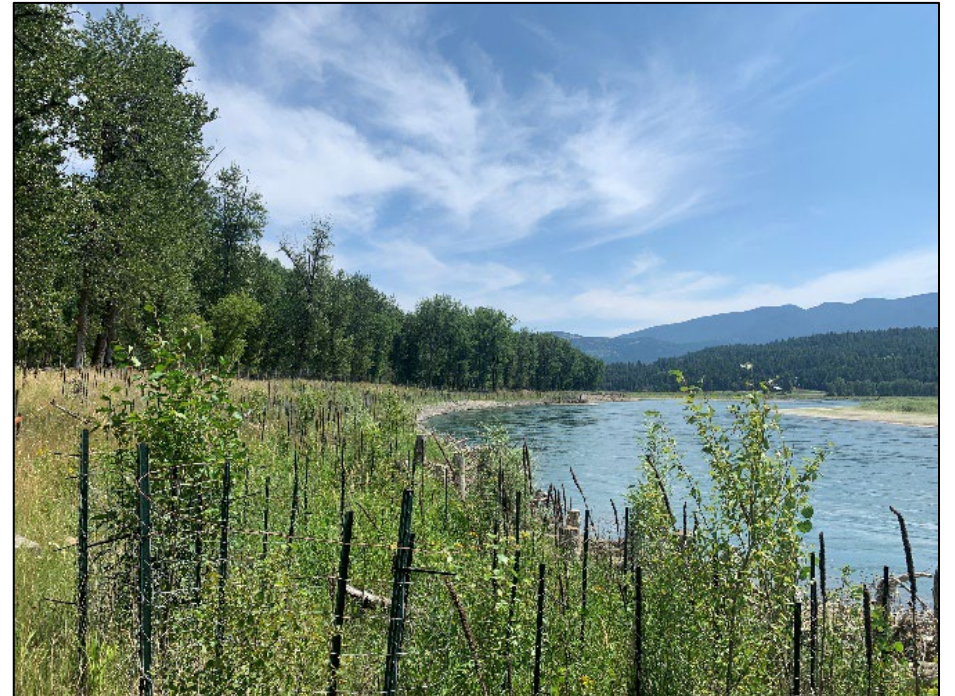
Inset floodplain and revegetation, Kootenai River, ID.

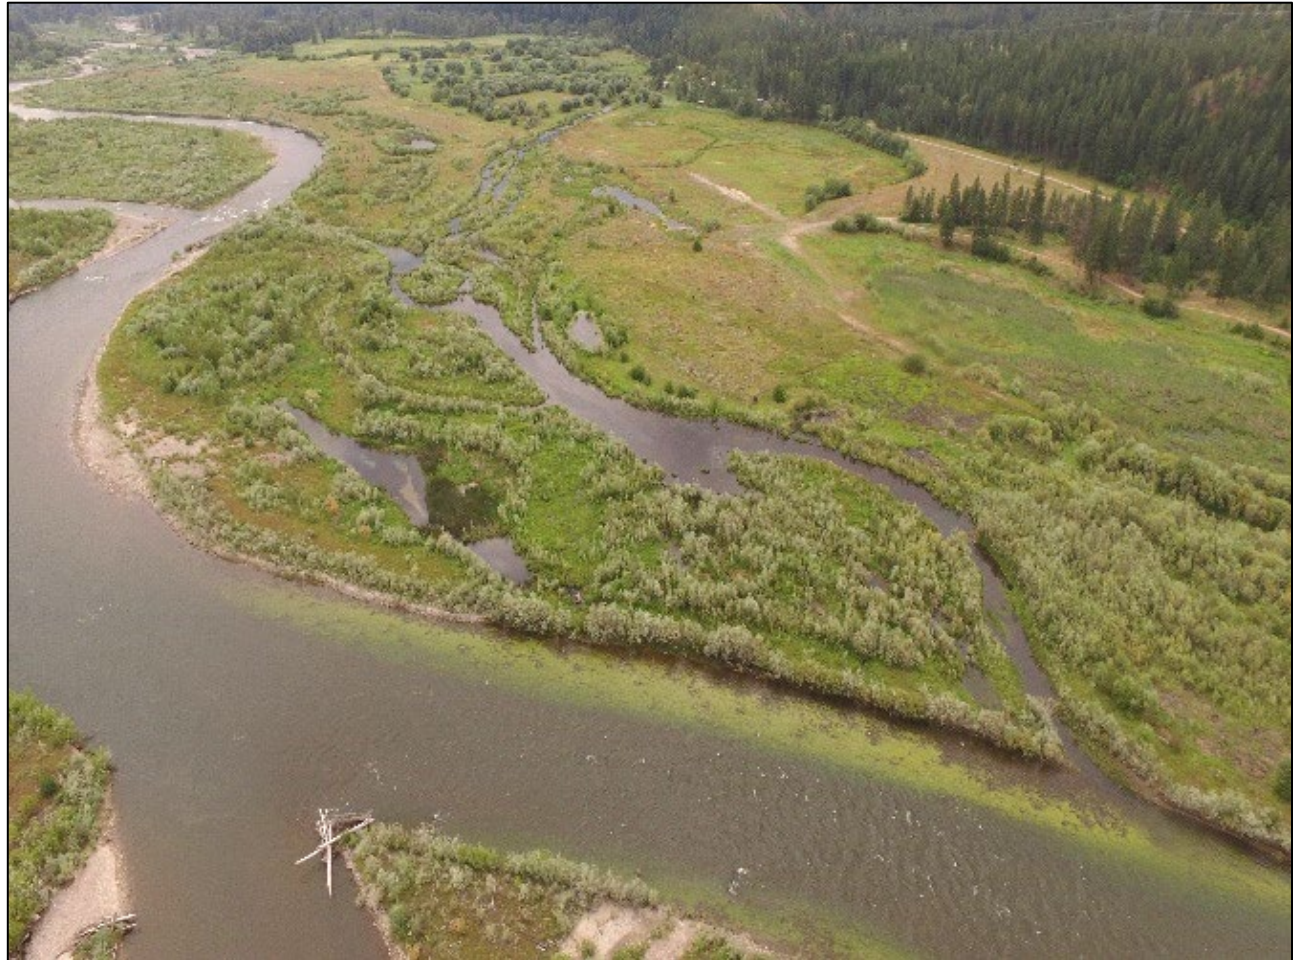
- Increase hydraulic (*i.e.* habitat) diversity and complexity
- Provide shallow, low energy areas that retain gravels
- Active at baseflow
- Proposed on existing low surfaces or new inset floodplain surfaces

Constructed side channel and alcove, Clark Fork River, MT.

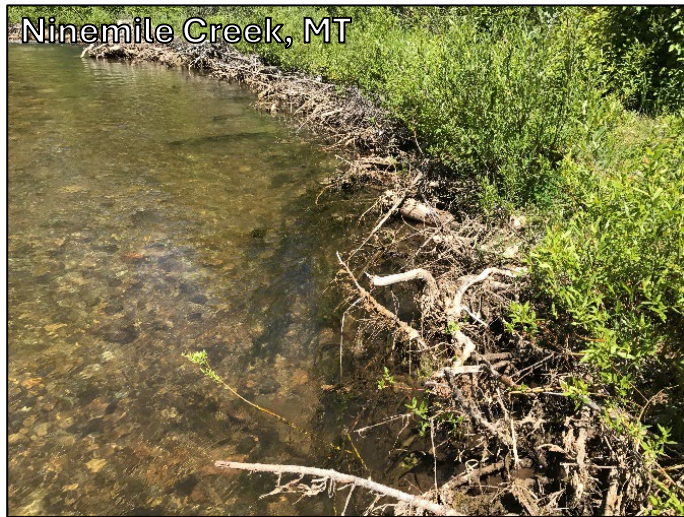
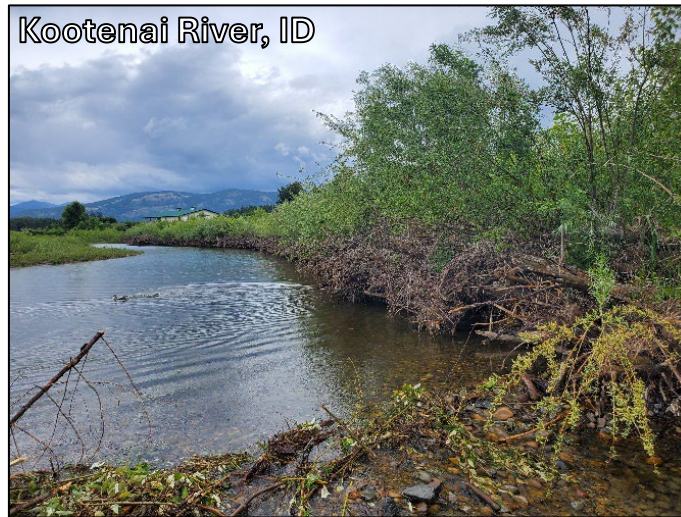
- Incorporated on new floodplain and side channel margins
- Provide complex habitat, cover, and shade
- Provide temporary stability until riparian vegetation is established
- Provide source of instream wood over the long term

Vegetated wood matrix structures.

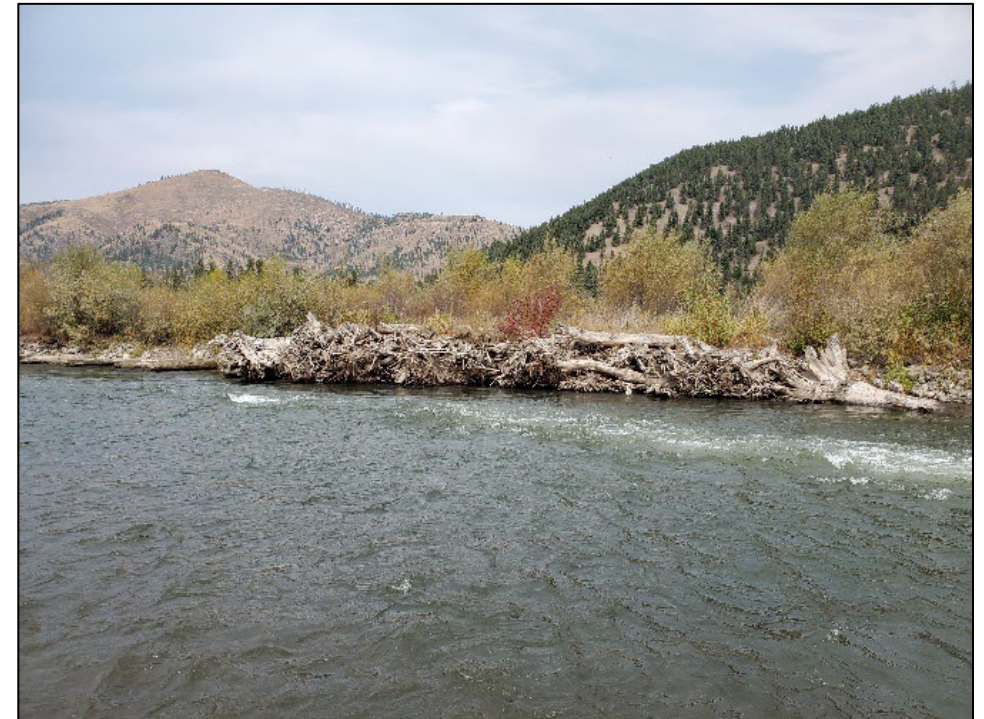
Large wood habitat structure, Clark Fork River, MT.
